THE EARLY NORMAN CHAPEL AT BALSDEAN

By N. E. S. NORRIS AND E. F. HOCKINGS

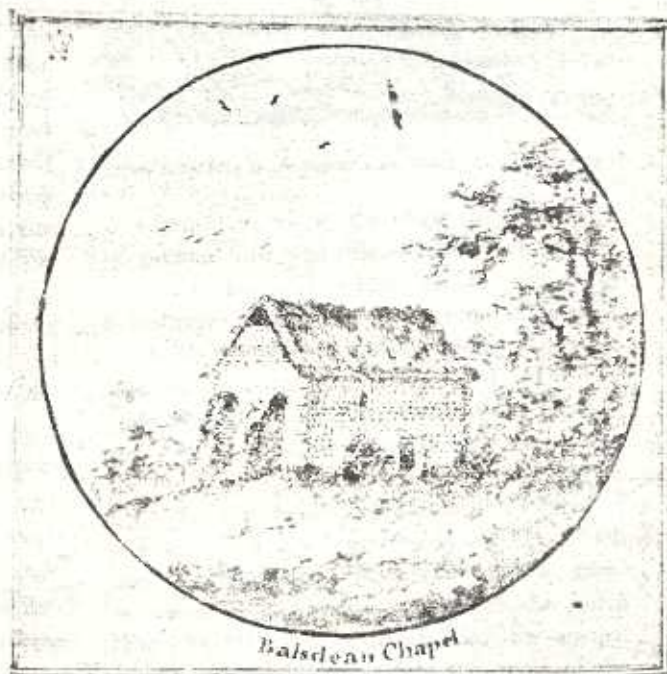
View by Lambert, circa 1775, in the Burrell Collection, British Museum (Fig. 2). Reproduced by permission of the Trustees of the British Museum

The earliest view we have of the chapel (Fig. 2) was drawn by James Lambert about 1775 and shows the nave roofed with thatch, and the ruined chancel walls projecting from the east end. Between these can be seen the chancel arch, and in the north wall a small round-headed window together with a doorway with a flat lintel. By 1780 the chapel had been desecrated and the nave used as a stable. At this time some of the surrounding ground was lowered, when several burials were disturbed. In 1850 Hussey, in his *Notes on the Churches of Sussex*, described the thatched roof as having three tie-beams with king posts and braces. The *Victoria County History of Sussex*, Vol. 7 (1940), under Balsdean, gives a plan of the nave showing the extent of modern alterations and a conjectural outline of the chancel. As already stated, the chapel ceased to exist when the nave was destroyed during army training in the late war.

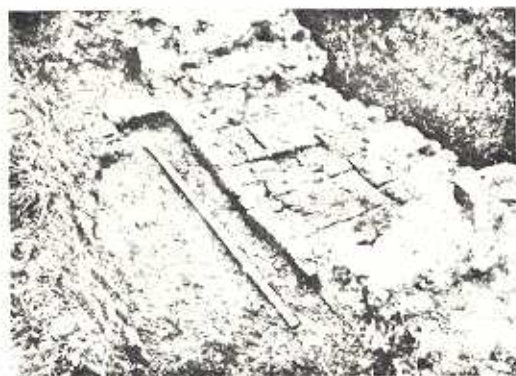
North doorway with glazed tiles from south-east (Fig 6)

The plan given in the *Victoria County History* shows a blocked-up doorway in the north wall of the nave. A cutting made at this point showed that underneath the blocking material was a floor made of glazed tiles (Fig. 6). These were 9 inches square and $2\frac{1}{2}$ inches thick, and had originally been covered with a dark green glaze of poor quality. During the period when the doorway was in use the glaze on these tiles had been considerably worn, and the tiles cracked. On uncovering the floor inside the nave, underneath a layer of cobbles which had formed the stable floor,

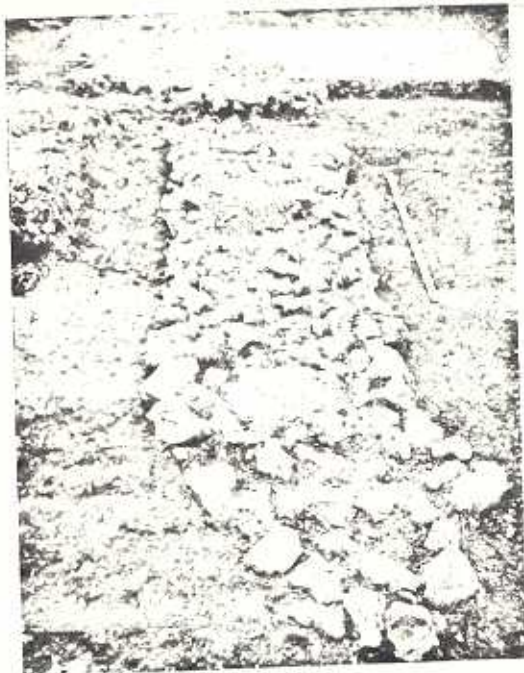
South chancel wall from the east, showing curve of apse (Fig. 4)

Adjacent to where the chalk ended an area of packed flint was discovered which proved to be a rectangular footing, almost certainly of a buttress. Owing to its peculiar inclination to the north wall of the chancel it suggested that the north east corner of the latter had not been square. The south wall of the chancel was next examined, when it was found that the footings were a few inches lower in the ground. On being completely uncovered it was seen that the easternmost portion, which was constructed of flint, showed the commencement of a definite curve to the north (Fig. 4). This is evidence for an apsidal chancel, which also explains the angle of the buttress on the opposite side.

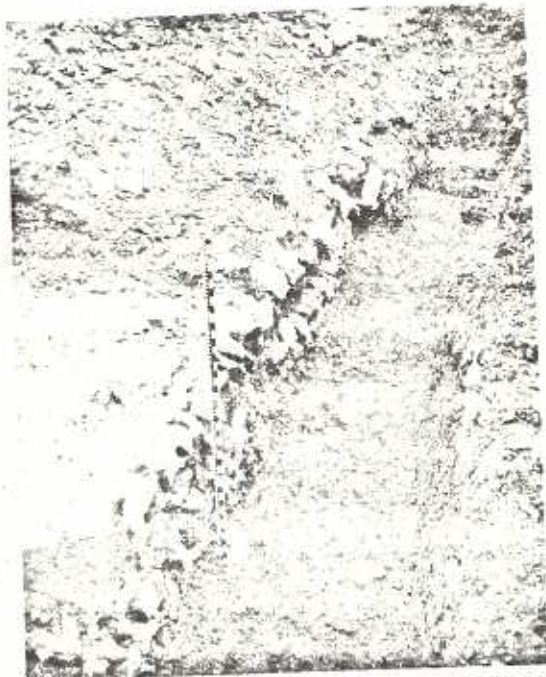
South wall of nave with greensand quoin in foreground and earlier ditch beneath wall—marked by the farther measuring rod (Fig. 5)

About half way along the south wall a ditch was discovered and found to run under the footing of the wall. From this ditch several sherds of Norman pottery were obtained, and also in the upper filling a small bronze book-clasp. The ditch had almost certainly silted right up before the chapel had been built

over it. The south west corner of the nave, on the outside, had one greensand quoin remaining (Fig. 5). The materials used for the construction of the footing for the south and north walls of the nave were found to be of two materials. The western portion is constructed of flints, while the eastern half is of rammed chalk. This was no doubt necessitated by the position of the building on the hill slope.
